RAPID BIOASSESSMENT OF THE
BLUE RIVER AND UPPER EEL RIVER WATERSHEDS
USING BENTHIC MACROINVERTEBRATES

for the Soil and Water Conservation Districts of
Noble & Whitley Counties

Study conducted during
June and October 1994

Study Conducted By:
Commonwealth Biomonitoring
7256 Company Drive
Indianapolis, Indiana 46237
(317) 887-5855

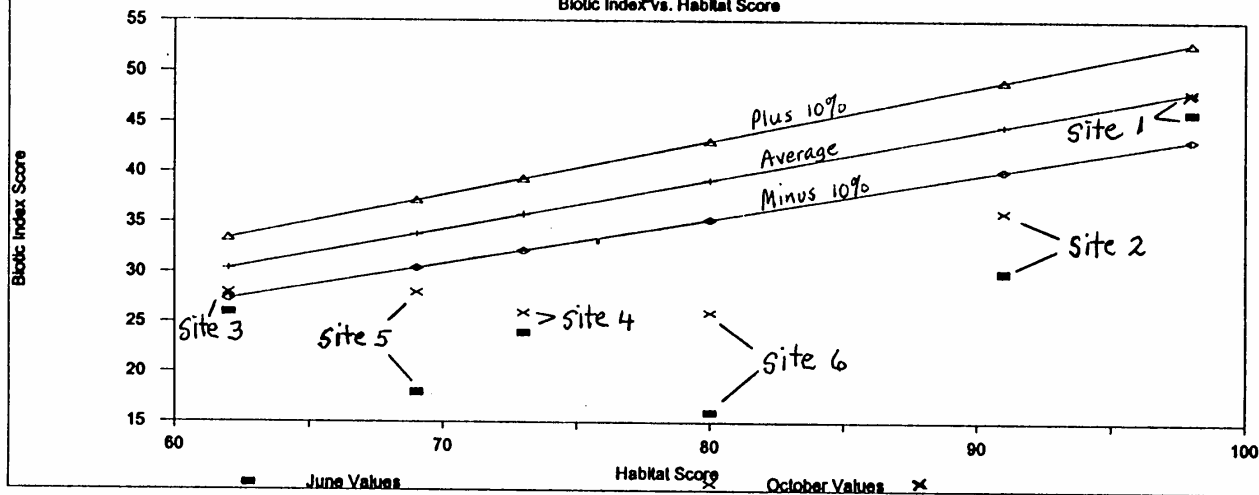
Figure 2
Biotic Index vs. Habitat Score

Figure 2 shows the normal relationship of biotic index scores to habitat values (a linear relationship according to [4]). The figure also shows a range of plus or minus 10%. When biotic index values fall outside this range, the site typically has degraded water quality. Figure 2 indicates that sites 2,4,5, and 6 had biotic values considerably lower than expected from their measured habitat values during the June sampling period. Therefore, these sites were probably affected by both degraded habitat and degraded water quality. Site 6 deviated farthest from the normal relationship, indicating that its water quality may have been worse than the other sites.

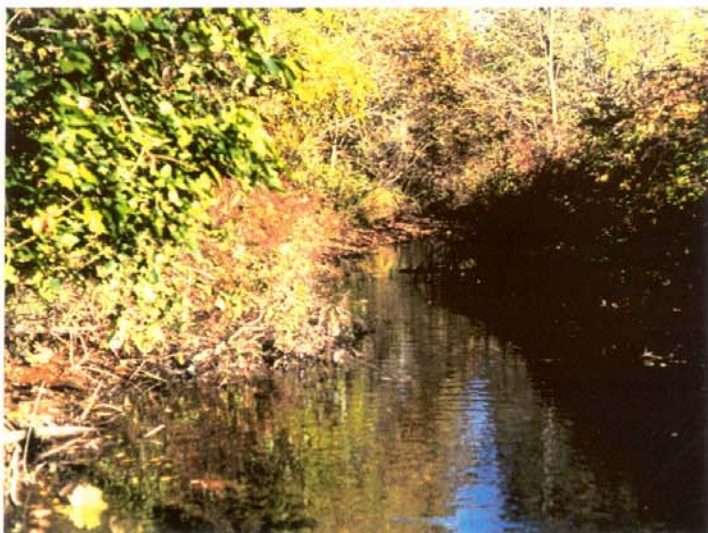
Tippecanoe River
Reference
Site 1

The upper Tippecanoe River was chosen as the "reference site" for this study. This stream, which like Blue River and Eel River is a tributary of the Wabash River, has been identified by numerous aquatic biologists as having an extremely diverse aquatic community with many "pollution intolerant" organisms present [e.g. 5]. The site chosen for study lies downstream from Baugher Lake near the small town of Wilmot in Noble County. At this location, the Tippecanoe River drains an area of about 85 square kilometers. This watershed also includes several glacial lakes having a total surface area of about 380 hectares. Agriculture is also an important land use in this watershed, but the stream is less extensively channelized than either Blue River or the upper Eel River.

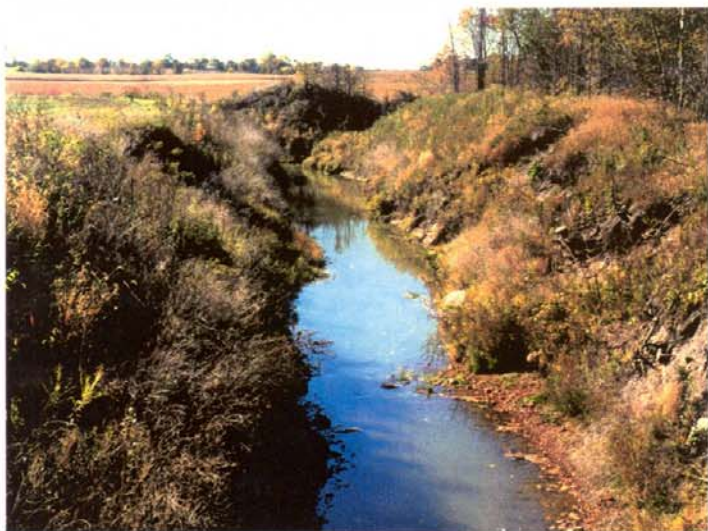
Blue River
Riley Road
Site 3

The scores indicate that the lowest habitat value in this study was at Site 2 (Blue River near Riley Road). This site was characterized by extremely steep, unvegetated bank slopes with no riparian vegetation. All study sites also suffered from various degrees of channel alteration, lack of shading, and sediment deposition.

3. Encourage local entities and landowners to provide some form of bank stabilization on Blue River downstream from Riley Road, where extremely steep banks are unvegetated and frequently slumping into the stream.

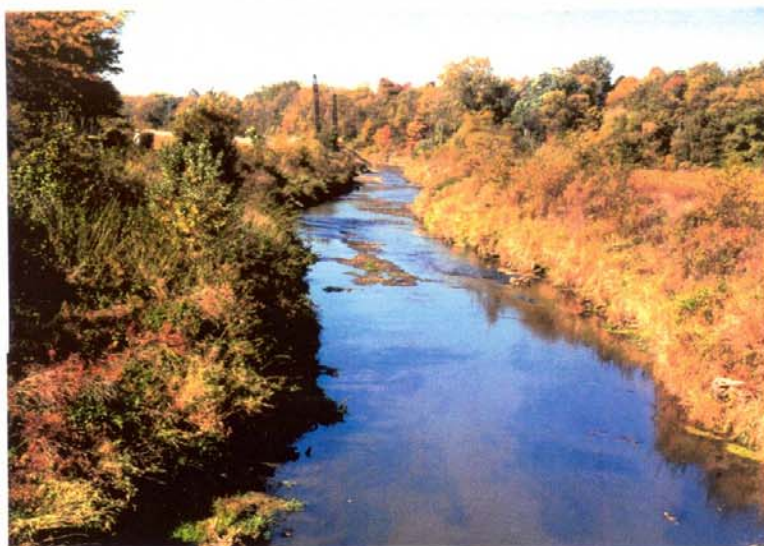
Eel River
Washington Road
Site 6

The most biologically depressed site occurred in the Eel River downstream from Blue River. Previous studies have shown that this site also had the lowest biotic index value for fish communities in the Eel River system. Water quality problems other than sedimentation may contribute to the depressed conditions at this site.
